# Case Study

## Weeth Pond, Penrose.

# Case Study 1 : Weeth Pond, Penrose

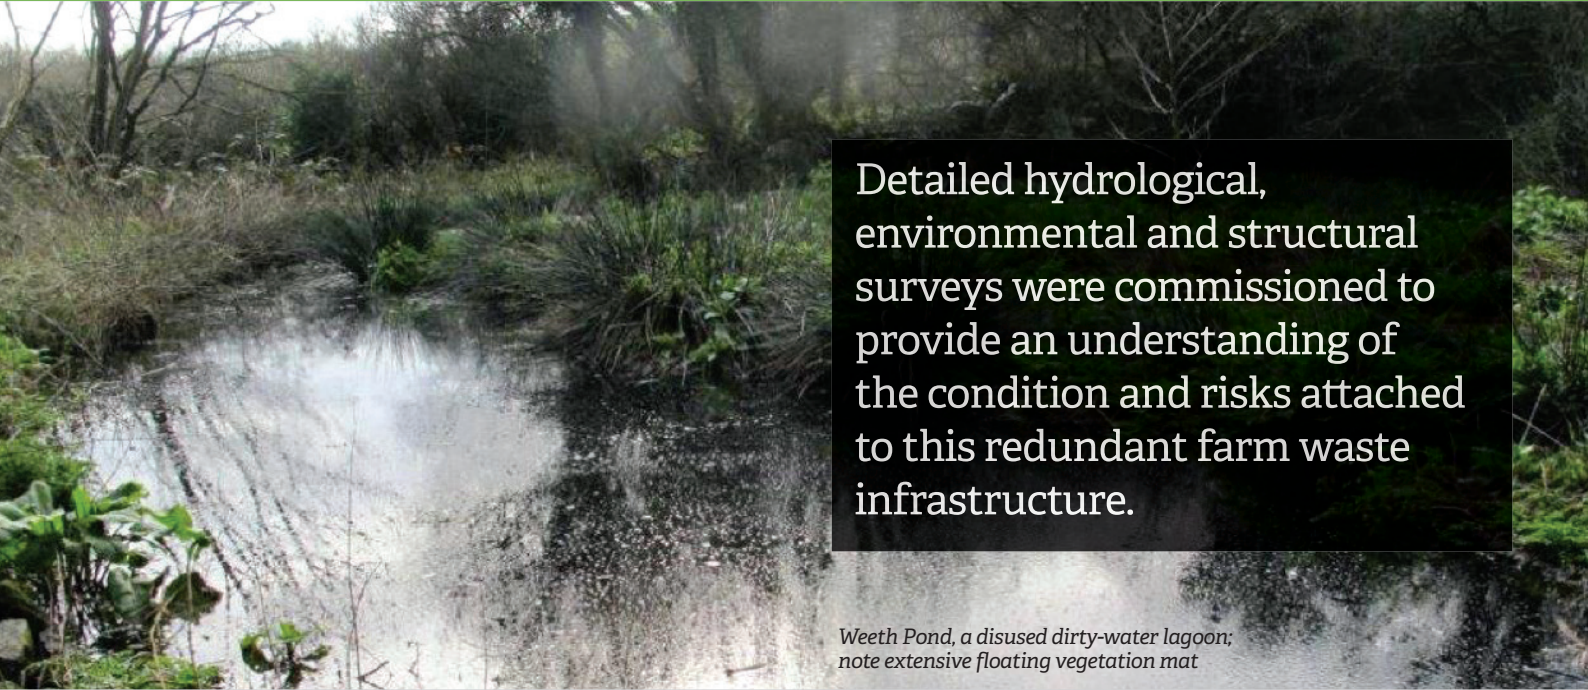
*Weeth Pond, a disused dirty-water lagoon; note extensive floating vegetation mat*

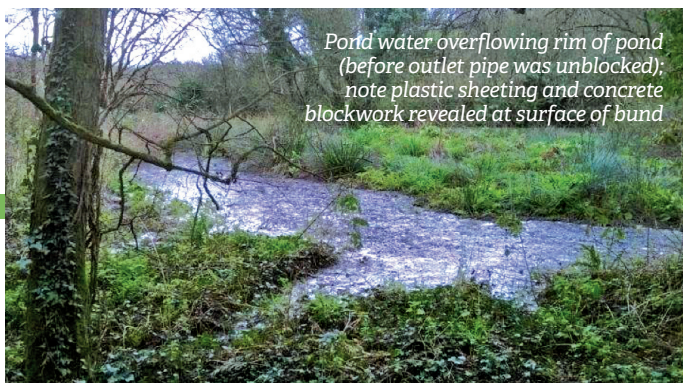
*Pond water overflowing rim of pond (before outlet pipe was unblocked); note plastic sheeting and concrete blockwork revealed at surface of bund*

Pond water overflowing rim of pond (before outlet pipe was unblocked); note plastic sheeting and concrete blockwork revealed at surface of bund

The structural survey was undertaken by PCA Consulting Engineers and highlighted that although the overall structure appeared sound, to reduce risks of overtopping in high rainfall periods the existing single 150mm drainage pipe should be replaced by two 450mm pipes, installed at a lower level in the retaining wall (thus reducing the risk of blockage and also any safety risk from deep water) Safety signs were also recommended.

Practical works were completed by MH Groundworks for the National Trust during early May 2018.
